# Seasons, Storms and Seawalls: A Comparison of Constrained and Unconstrained Beaches in Groton, Connecticut

ABSTRACT

Chairperson of Supervisory Committee: Doug Thompson  
Department of Physics,  
Astronomy and Geophysics

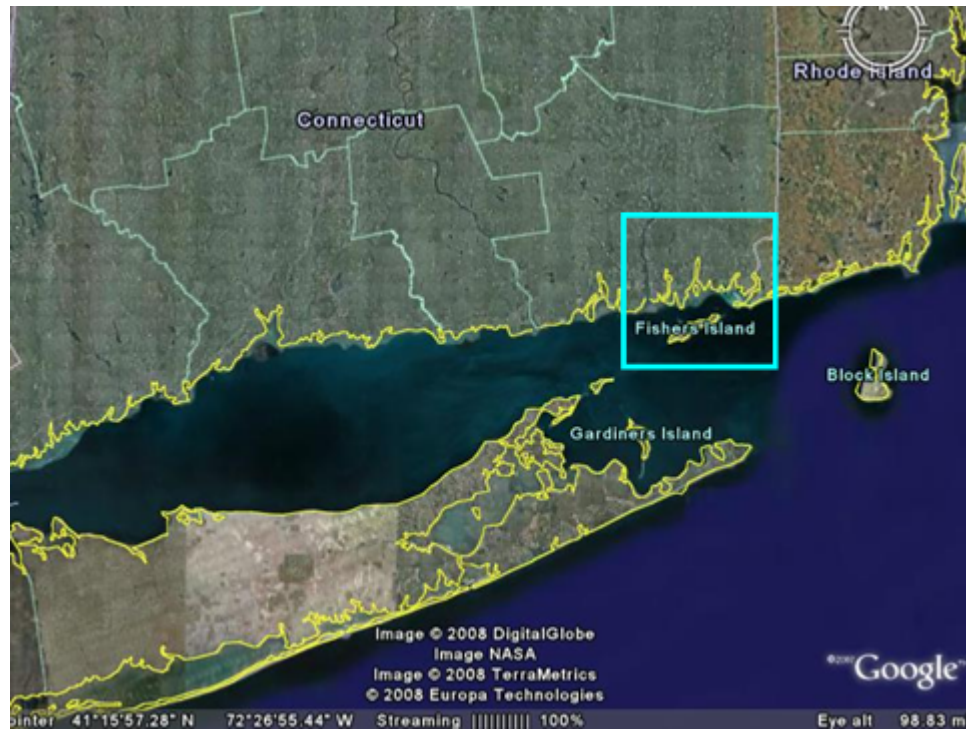
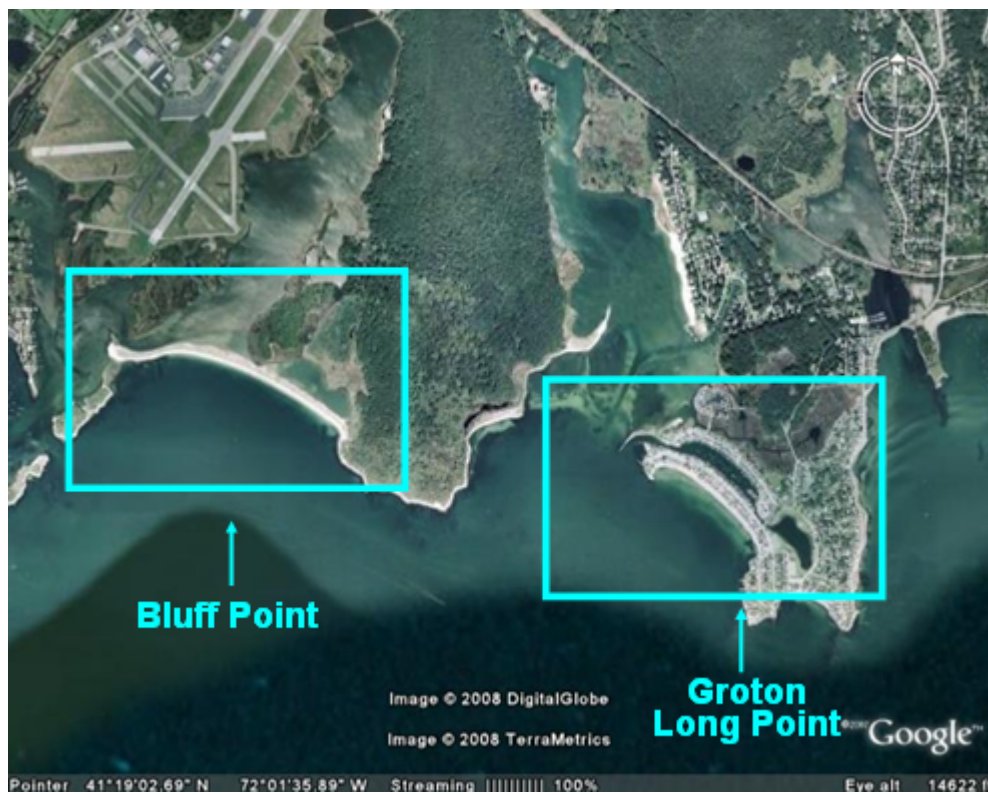
Figure 3.1: Top: Connecticut with the study section shown in the square. Bottom: Bluff Point and Groton Long Point beaches (Google Earth, 2007).

Bluff Point and Groton Long Point, the two areas surveyed, are extremely close in proximity to each other (Figure 3.1). Long Island Sound acts as a wave barrier to the two beaches, limiting the fetch of the systems. Both beaches are oriented to the SSW, giving them comparable fetch, wind and wave energies. Bluff Point can be considered a welded barrier, with the Bluff as one headland and Bushy Point as the other. As the glaciers receded, large meltwater deposits formed and filled channels, shaping streams that led into a sediment-dammed lake behind Bluff Point (Stone et al., 2005). Deltas in the glacially-fed lakes formed due to the heavy accumulation of sediment being released from the glaciers. The lake continued to fill until it breached the terminal moraine that dammed it and spilled into the present day Long Island Sound. As a result, the beach at Bluff Point is composed of glacial meltwater deposits. Groton Long Point is more complicated due to the seawall, but can be classified as a welded barrier between two headlands. It is presumed that Groton Long Point is also composed of glacial meltwater deposits that were carried downstream along Fort Hill Brook.

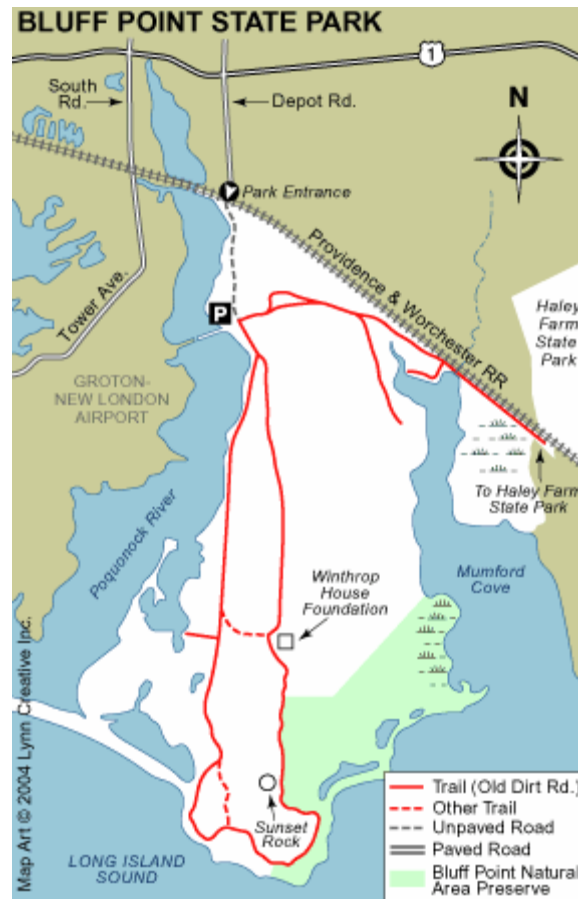
Figure 3.2: Map of Bluff Point State Park.  
 (<http://www.ct.gov/dep/lib/dep/stateparks/maps/bluffpoint.pdf>)

Bluff Point can be considered a welded barrier, with the Bluff as one headland and Bushy Point as the other. Sediment is coarser towards the bluff but becomes finer moving out towards Bushy Point. Bluff Point used to be developed with cottages lining the beach. However, the 1938 hurricane destroyed these houses and the community was not rebuilt. The public can only access the beach by foot or nonmotorized vehicle. Because it is along Long Island Sound, it is fetch limited, with waves smaller than 1.0 m during calm conditions. The beach has a small dune system and is backed by a marsh and lagoon.

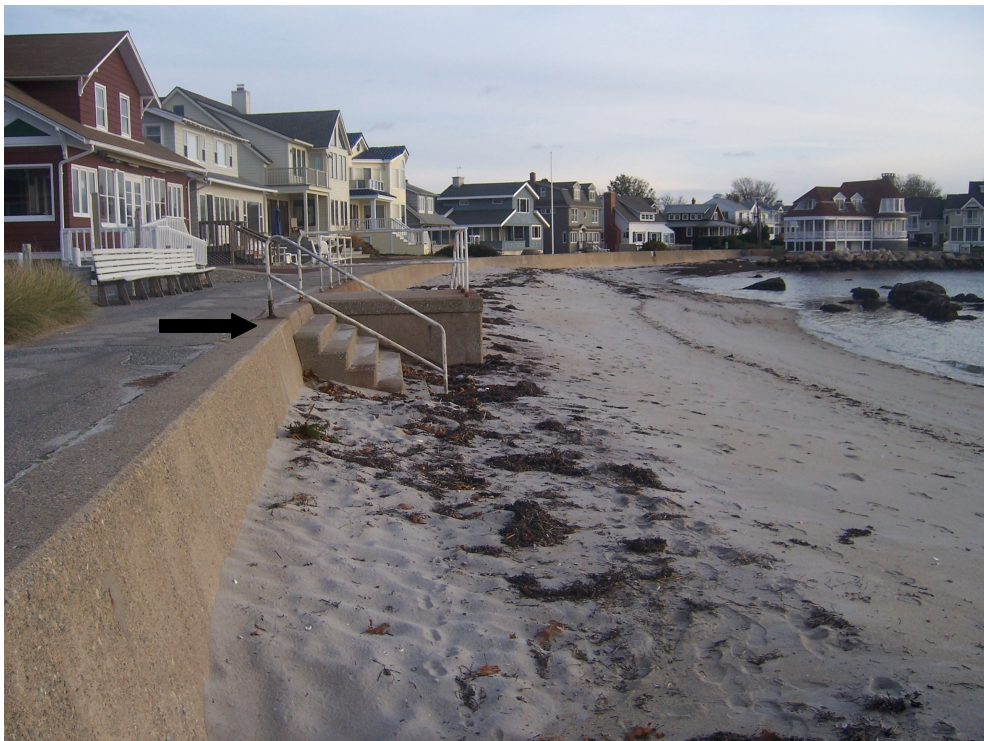
Figure 4.1: Benchmark location for Groton Long Point on the westerly staircase. Arrow indicates the location.

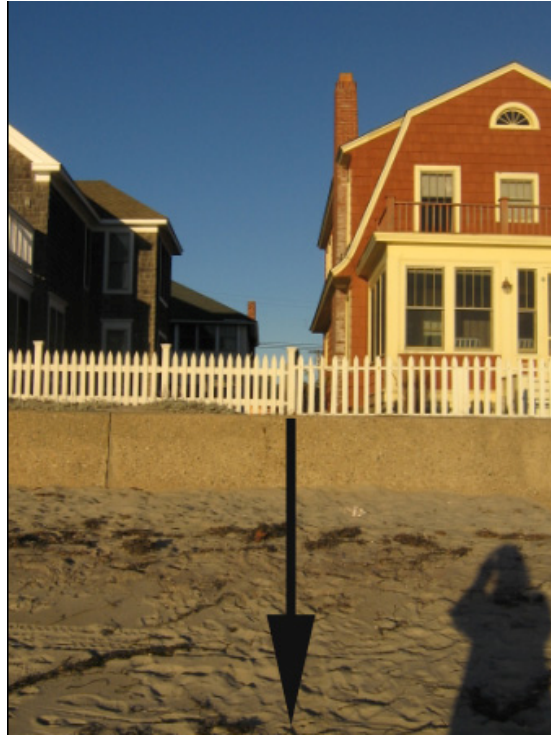
Figure 4.2: The Groton Long Point transect known as Picket Fence. The arrow depicts the transect line followed.

The benchmark for Groton Long Point was measured at the concrete base of the railing on the westerly staircase (Figure 4.1). The first transect, called Picket Fence, stretched perpendicular from the seawall adjacent to the picket fence and between two houses to the water (Figure 4.2). The transect to the west is House 32, which extended perpendicular from the non-porch side of House #32 into the water (Figure 4.3). Both transects included the berm, beach face and any bar or trough. The autolevel was placed in front of the house called “The Big Dipper” to allow both surveys to have the same tripod location.

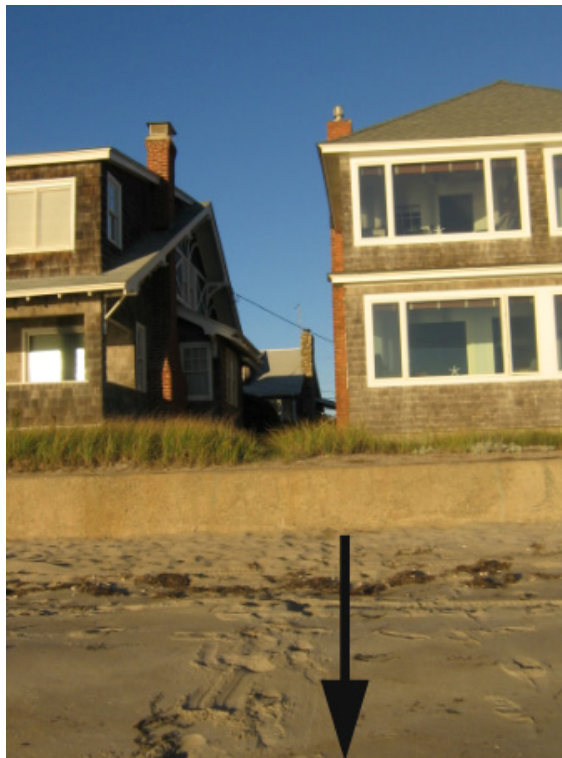
Figure 4.3: The second Groton Long Point transect known as House 32. The arrow depicts the transect line followed.

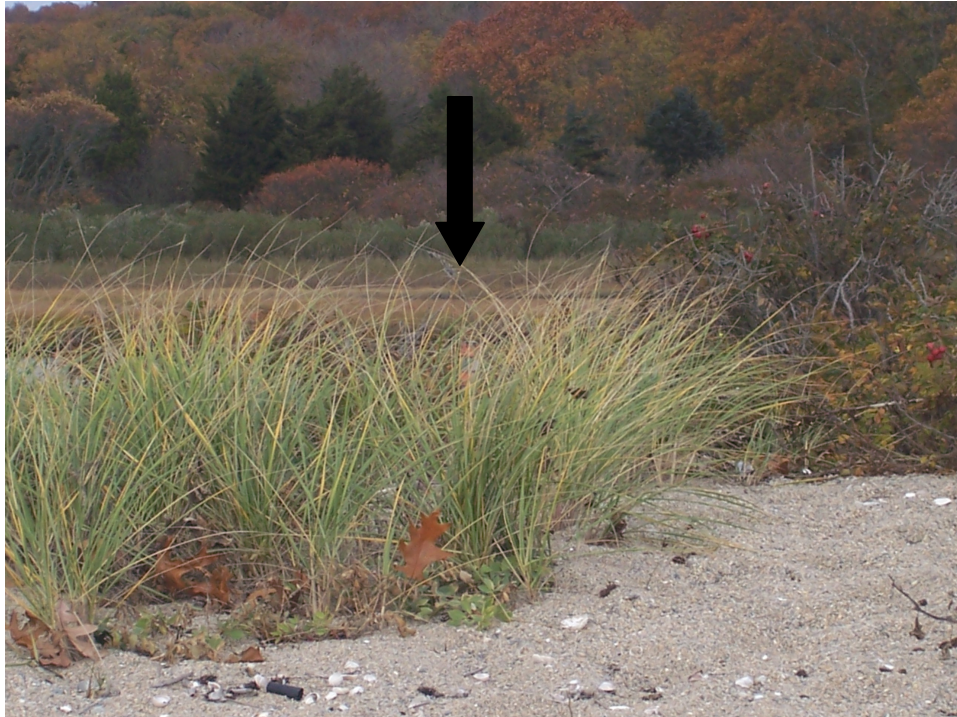
Figure 4.4: Benchmark location for Bluff Point. Arrow indicates the location of the orange stake.

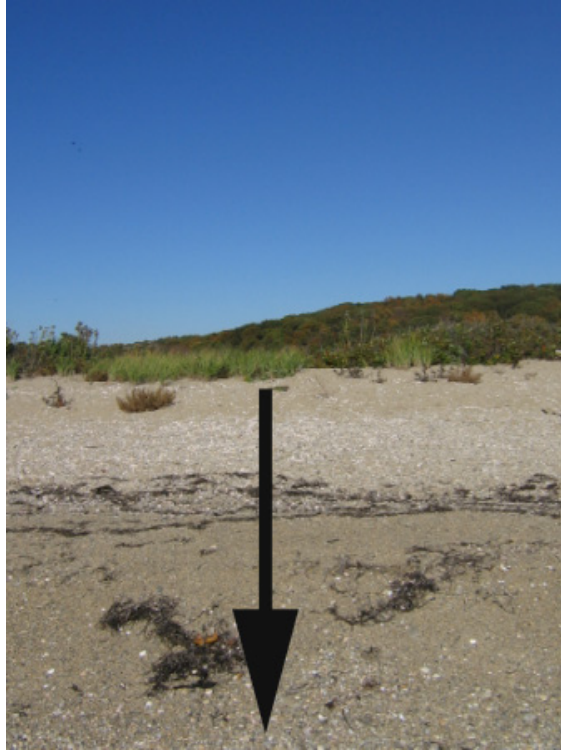
Figure 4.5: The Bluff Point transect known as Orange Stake. The arrow depicts the transect line followed.

The benchmark for Bluff Point was taken on top of an orange and white stake on the upper dune of the beach, approximately 90 m from the bluff (Figure 4.4). Transects were located using the methods section from previous research (Campbell, 2004). Transect one, called Orange Stake, was laid perpendicular from the orange stake, over the dune and down to the water (Figure 4.5). This transect included the beach’s dune, berm, beach face, and any bar and trough systems under water. The second transect, called Sand Fence, extended perpendicular from the end of the fallen sand fence into the water (Figure 4.6). This transect may not have been the original Sand Fence transect location because it looked as if the fence had been knocked over  $\pm 0.5$  m. The Sand Fence transect included the berm, beach face, and any bar and or trough systems. Again, the autolevel was set in between the two transect locations.

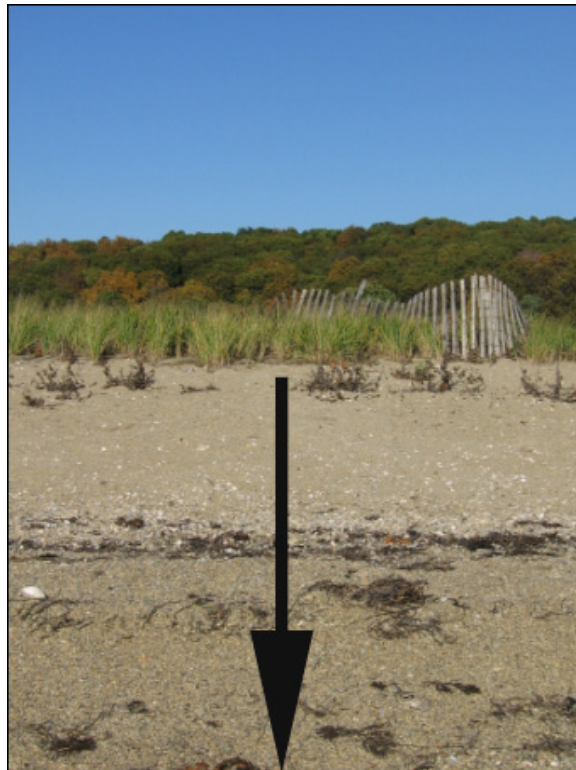
Figure 4.6: The Bluff Point transect known as Sand Fence. The arrow depicts the transect line followed.

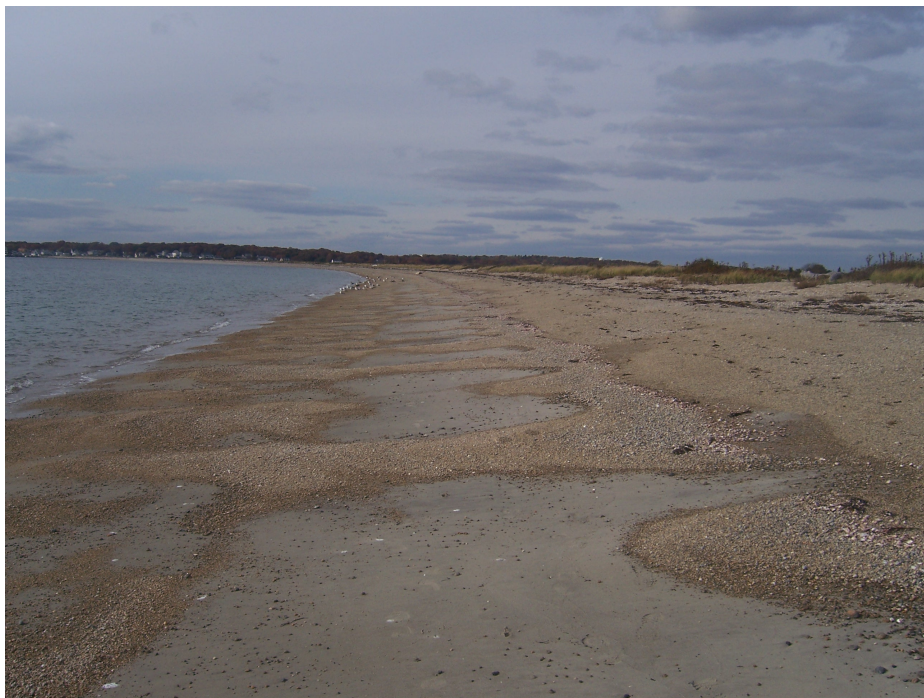
Figure 5.8b: Image of Bluff Point showing cusp development in post-storm survey on November 8, 2007.

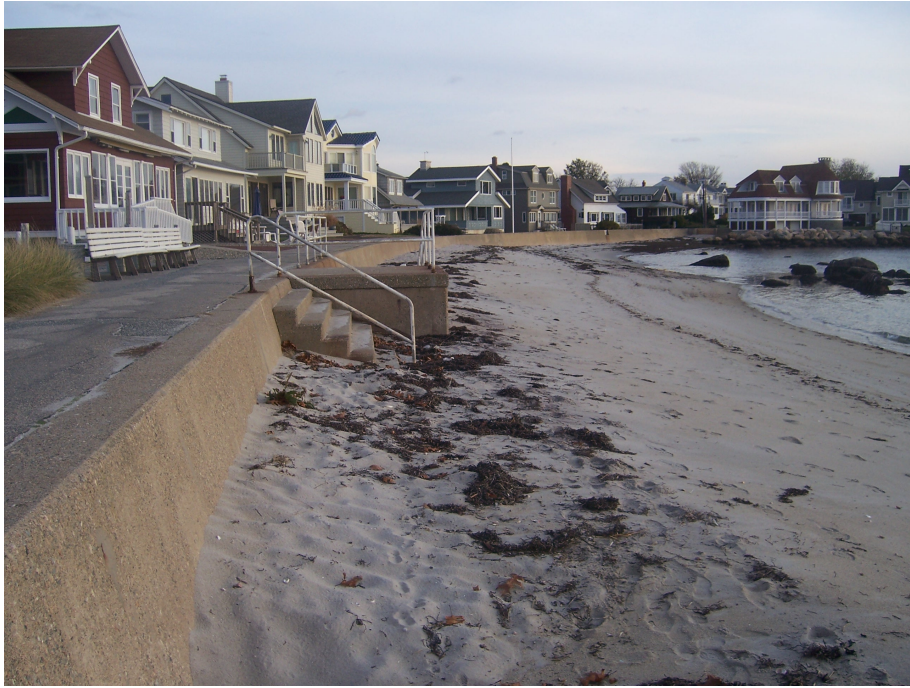
Figure 5.17: Groton Long Point's accumulation of debris along the staircase after Tropical Storm Noel. The survey was taken on November 8, 2007.

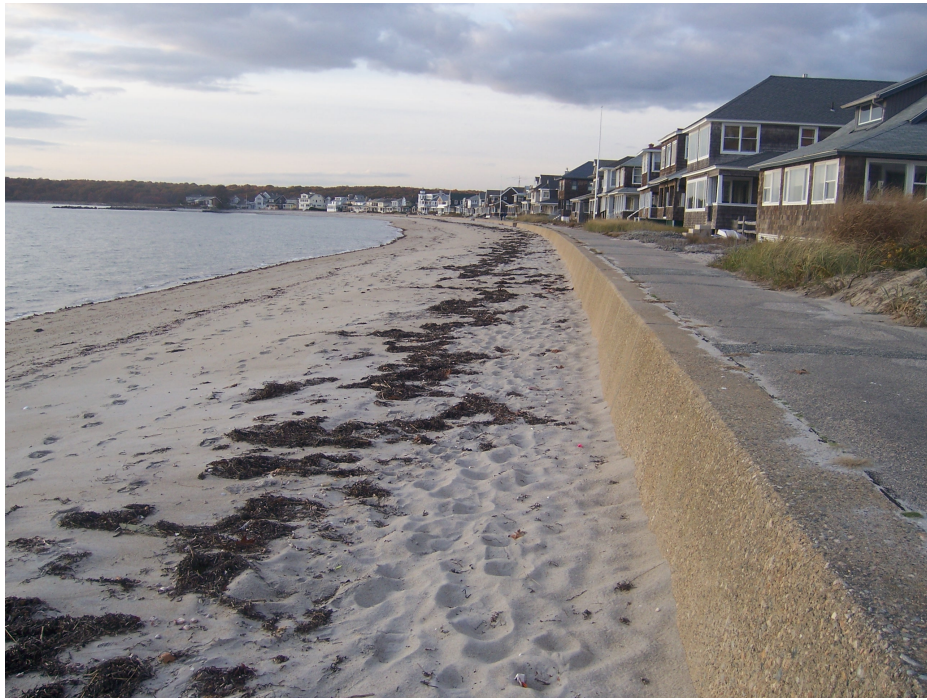
Figure 5.20: Groton Long Point's wrack line after Tropical Storm Noel. The survey was taken on November 8, 2007.
